# Inspection Report

## Sample Home Inspection

**TMK Inspections**

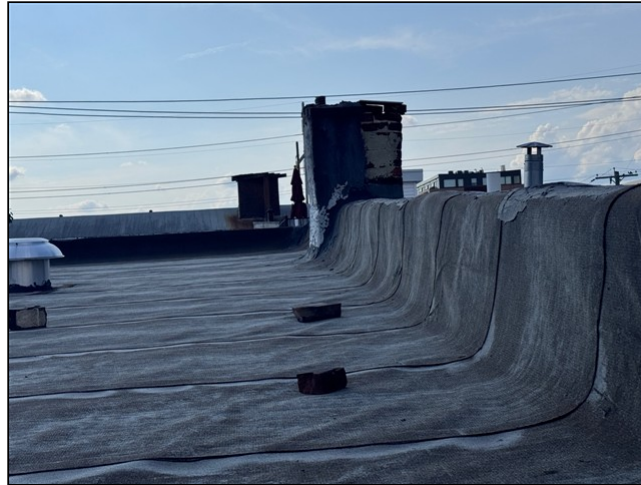
1.1

The chimney mortar crown is missing or significantly deteriorated. This leaves the chimney vulnerable to water entry and masonry deterioration. A qualified chimney or masonry contractor should evaluate and repair as needed.

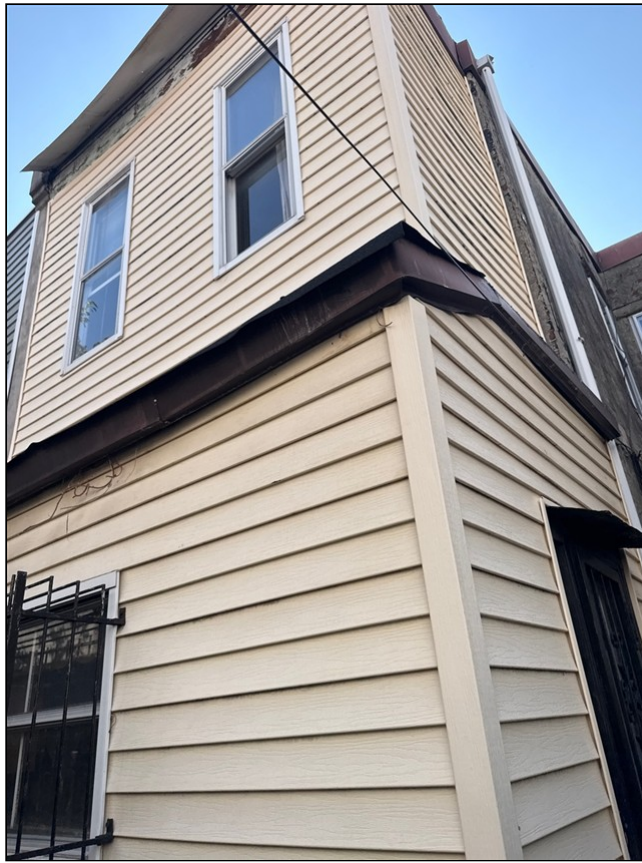
1.2

It is recommended to install a gutter on the lower rear roof with the downspout to ensure proper

drainage.

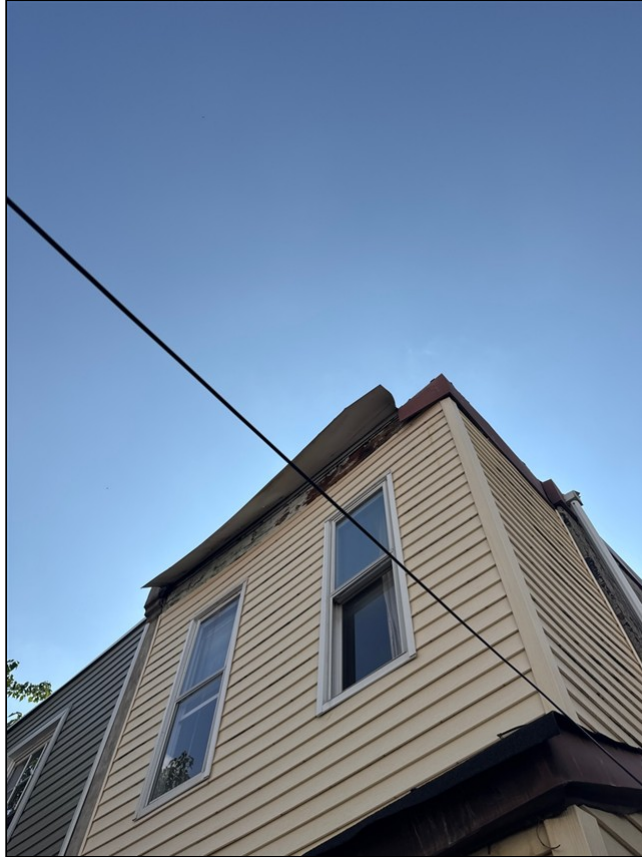
2.0

(1) The rear fascia trim is loose and needs to be corrected.

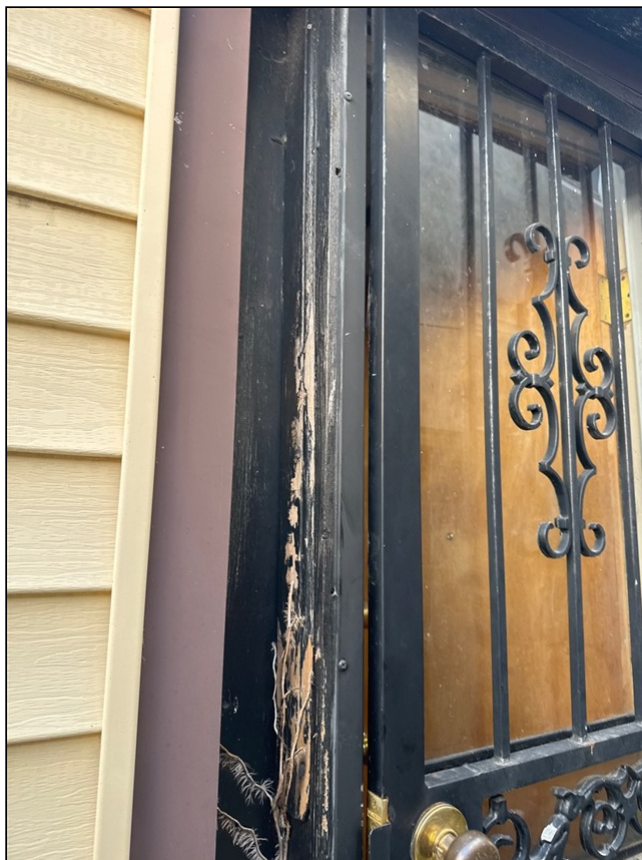
2.0

(2) Wood rot or deterioration was observed at exterior components. Deteriorated wood can worsen with continued moisture exposure and may conceal additional damage behind finished surfaces. A qualified

contractor should evaluate the affected areas, identify and correct moisture sources where possible, and repair or replace deteriorated materials as needed.

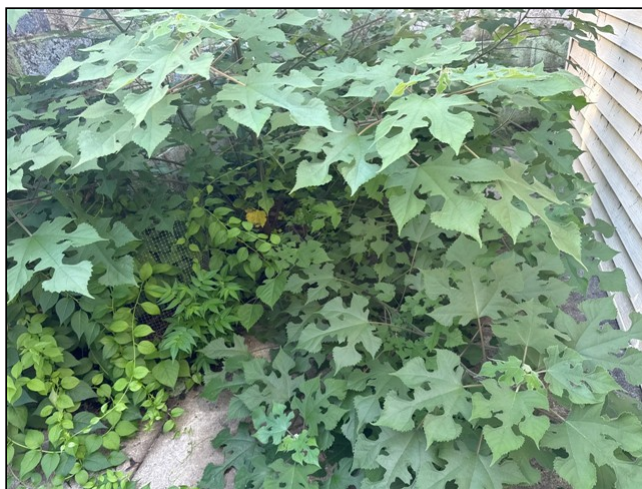
2.2

(1) Dense vegetation was observed near the exterior. Vegetation can limit inspection, trap moisture, and contribute to pest access. Trimming or removal is recommended.

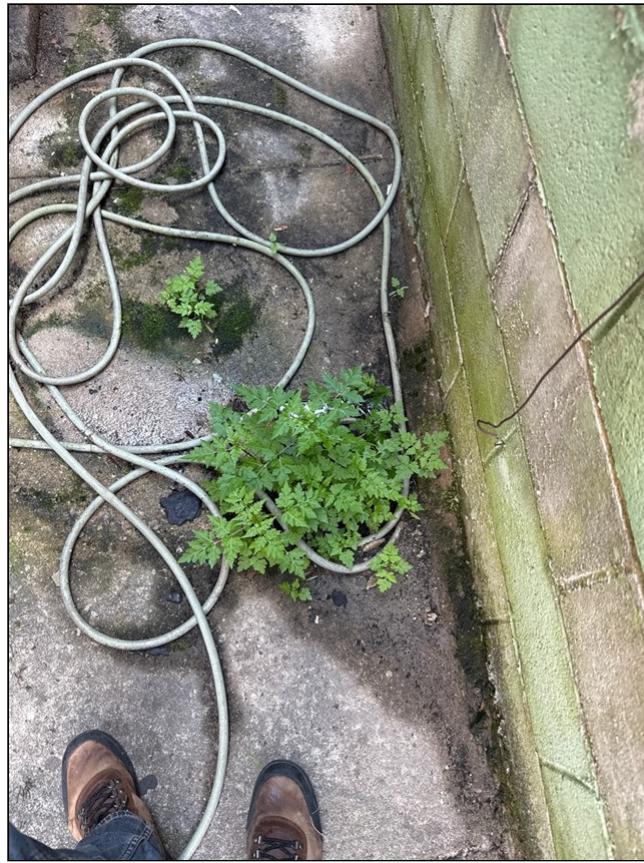
(2) The exterior storm drain is blocked or restricted. This can prevent proper drainage and may

contribute to water accumulation near the home. A qualified contractor should clear and repair as needed.

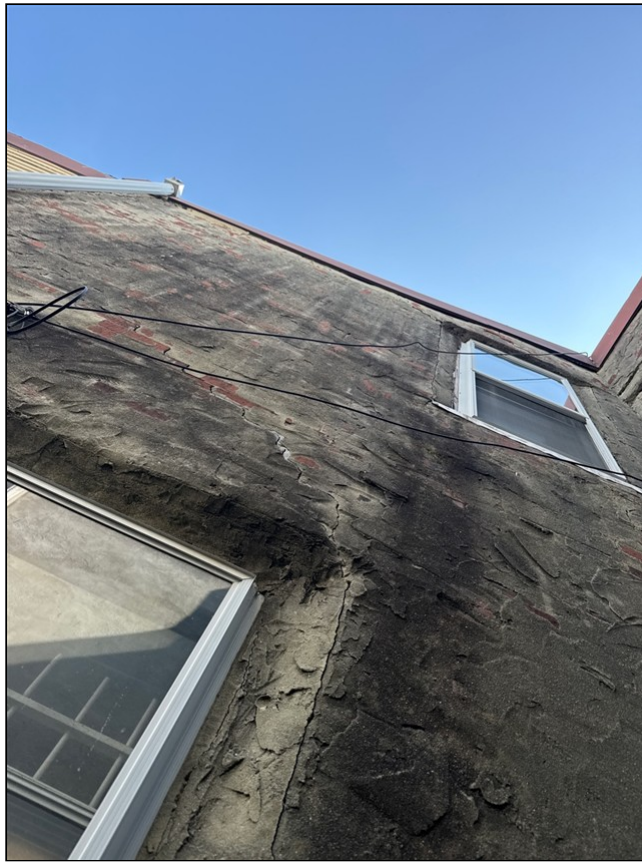
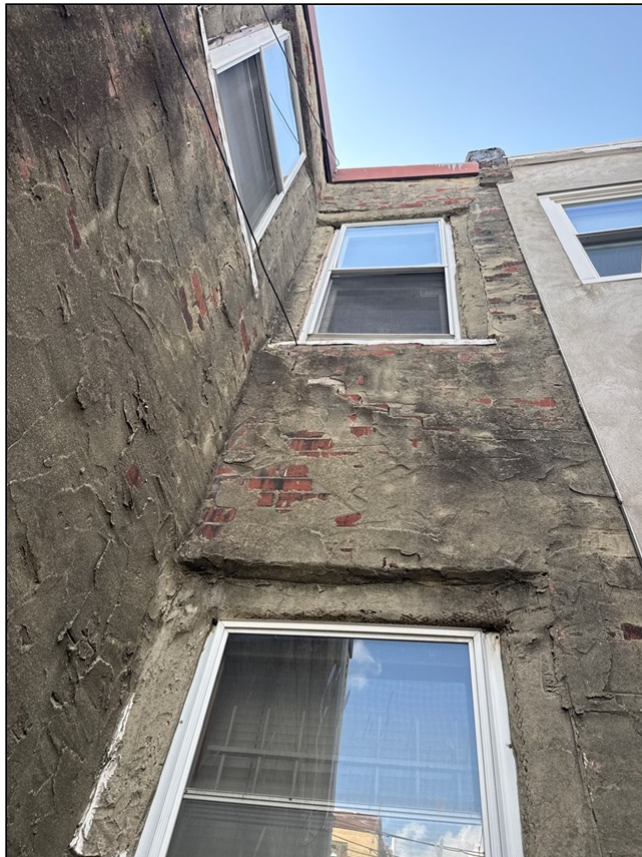
3.0

(1) Deteriorated brick or mortar joints were observed. Masonry deterioration can worsen with moisture

exposure and may lead to loose masonry. A qualified mason should evaluate and repair as needed.

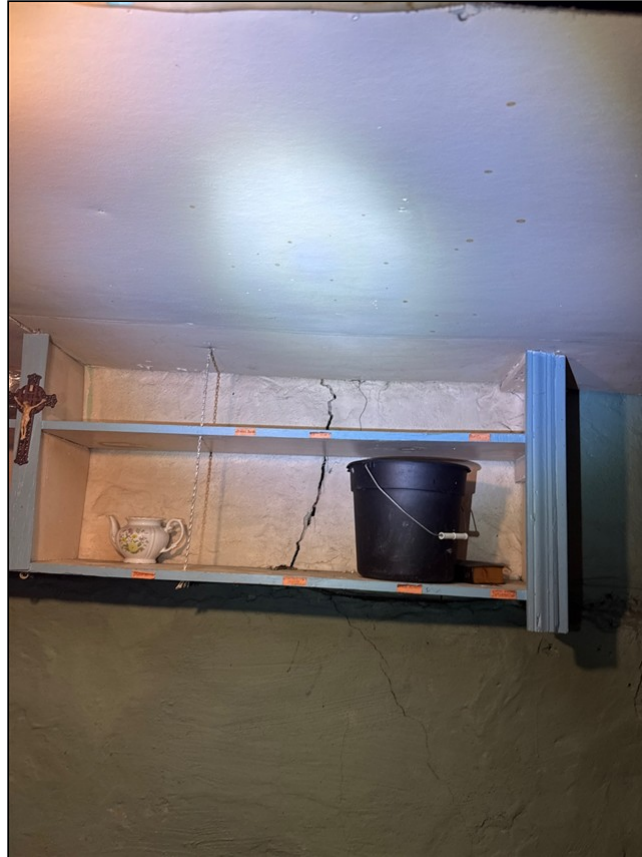
3.0

(2) There is a large crack in the party wall in the basement that extends all the way up to the top floor. This could be a structural issue. They should qualified brick masons, structural contractors, or engineers to further evaluate and determine the extent of the problem.

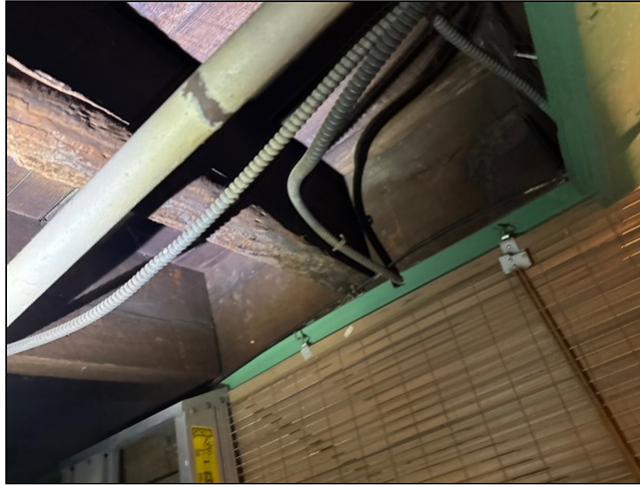
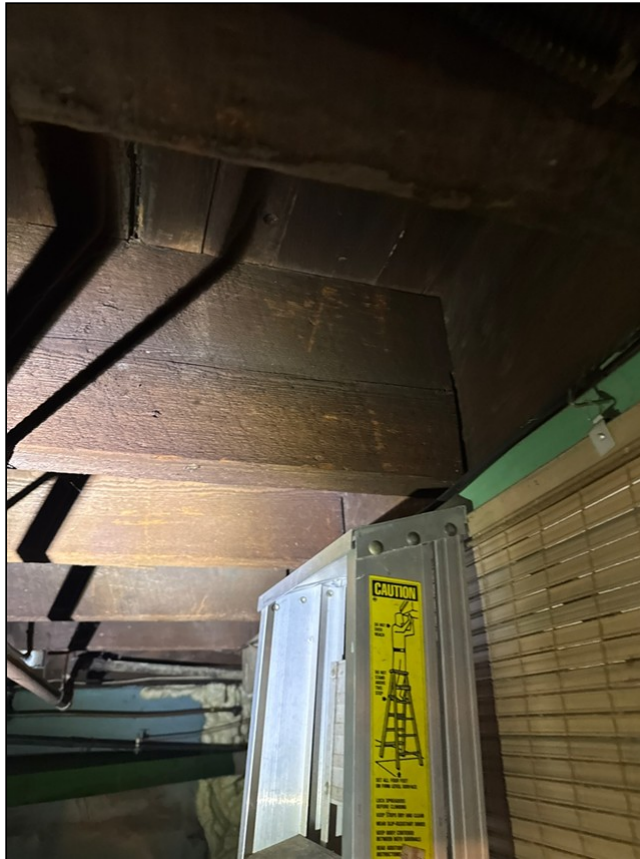
3.0

(3) Joist hangers or improved framing connectors are recommended where floor joists meet the stairway beam or similar framing. This can improve attachment and long-term support. A qualified contractor should install appropriate connectors as needed.

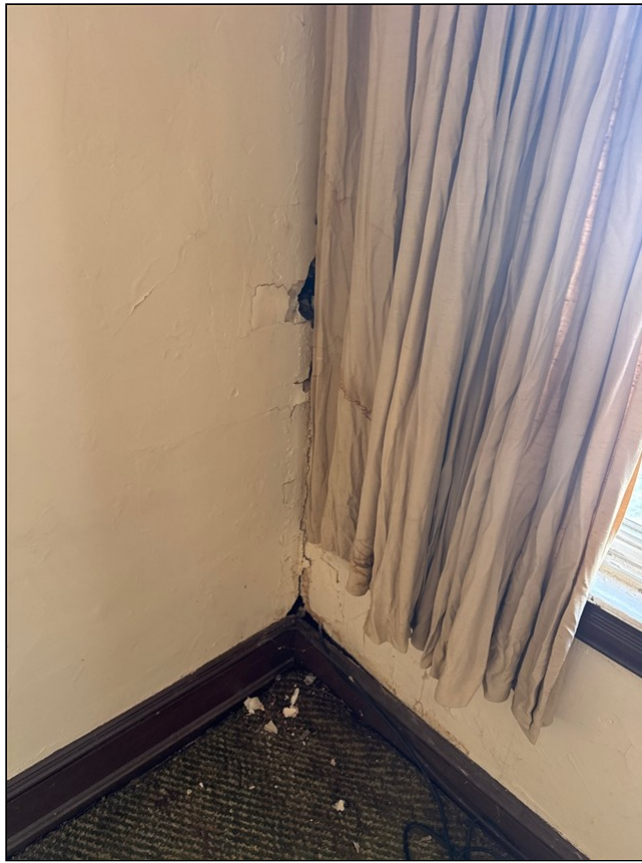
3.0

(4) The back wall in the rear bedroom has sustained significant water damage, most likely from the previous roof. As a result, this outer wall is loose and will most likely need to be rebuilt. A qualified contractor

should further evaluate the situation for corrections.

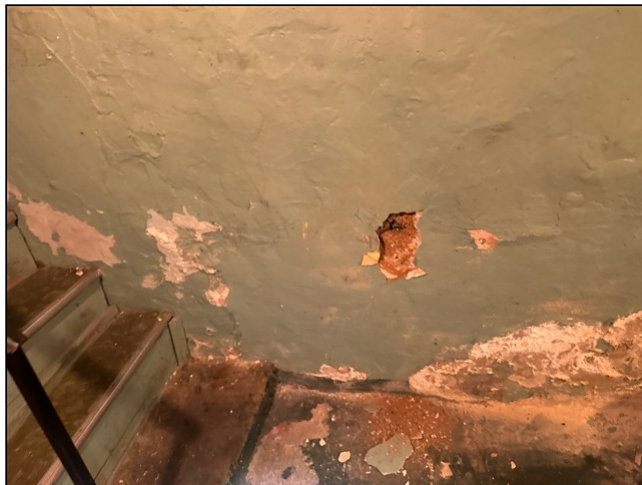
3.0

✂ (5) The parging on some of the foundation walls, as soon as you walk down the steps, is deteriorated and should be redone. A qualified mason should correct it.

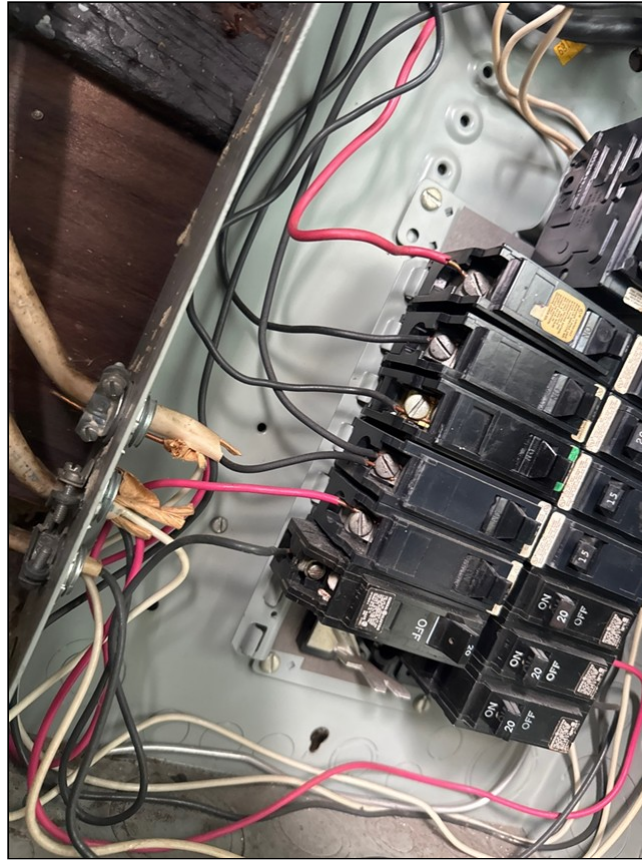
4.1

(1) An overloaded breaker is found in the panel. A qualified electrician should perform corrections to ensure safety.

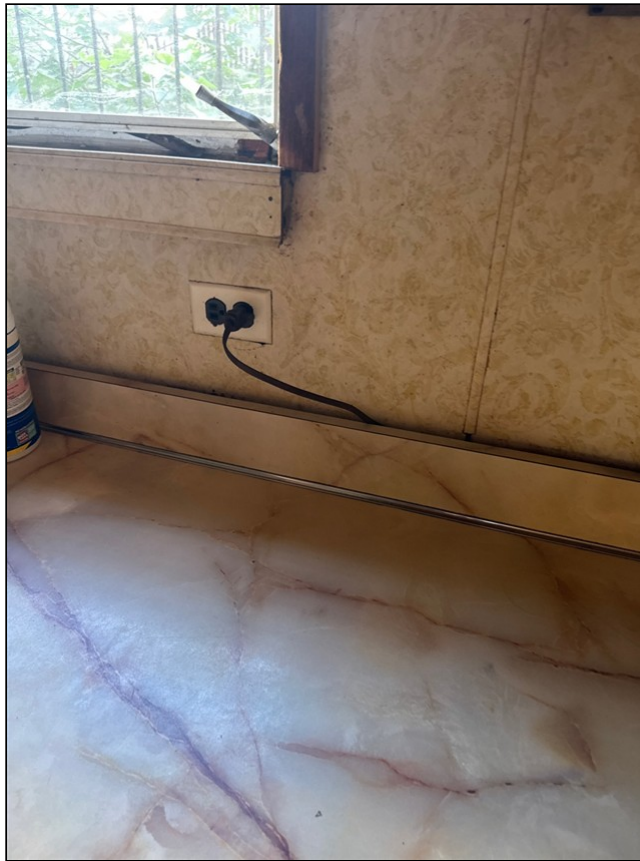
4.2

(1) GFCI protection was not observed at multiple expected locations. This is a safety concern because shock risk is higher near water, damp areas, garages, exterior locations, and similar areas. A qualified

electrician should evaluate and install GFCI protection where appropriate.

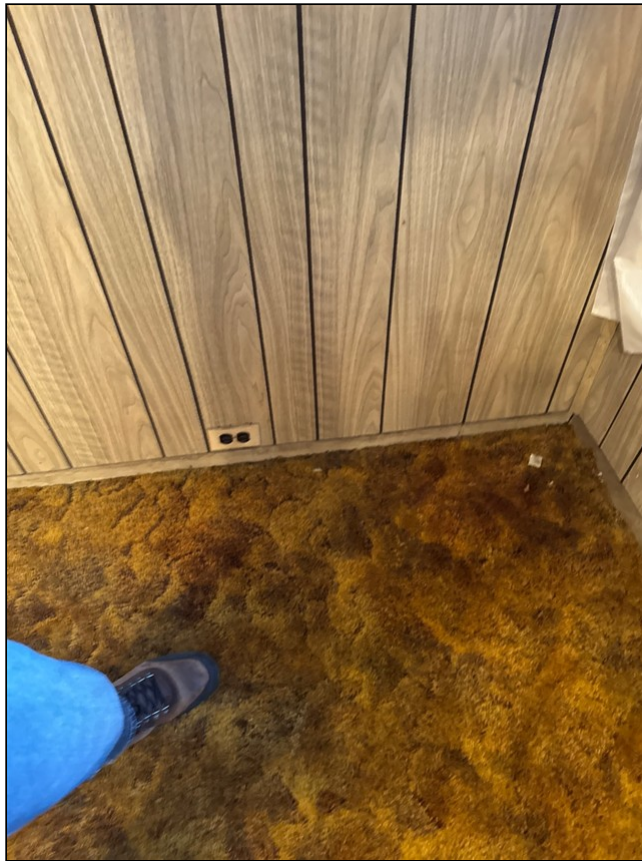
4.2

(2) Two-prong receptacles are present. This is common in older homes, but these receptacles generally lack equipment grounding and may not be suitable for all modern devices. A qualified electrician

should evaluate upgrade options where grounded receptacles or added protection are desired.

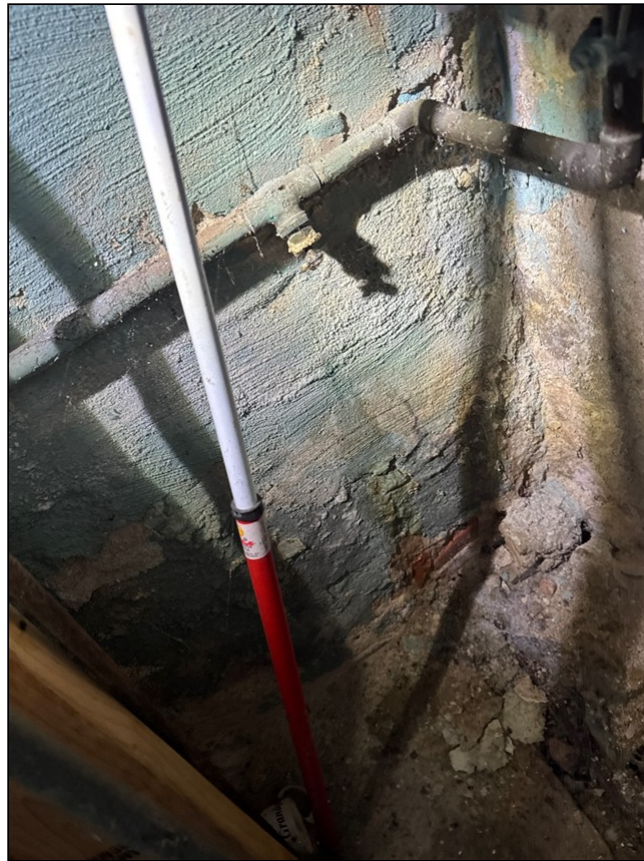
5.0

(1) The water shut off valve is completely corroded and is leaking. Replacement is needed by a

qualified plumber.

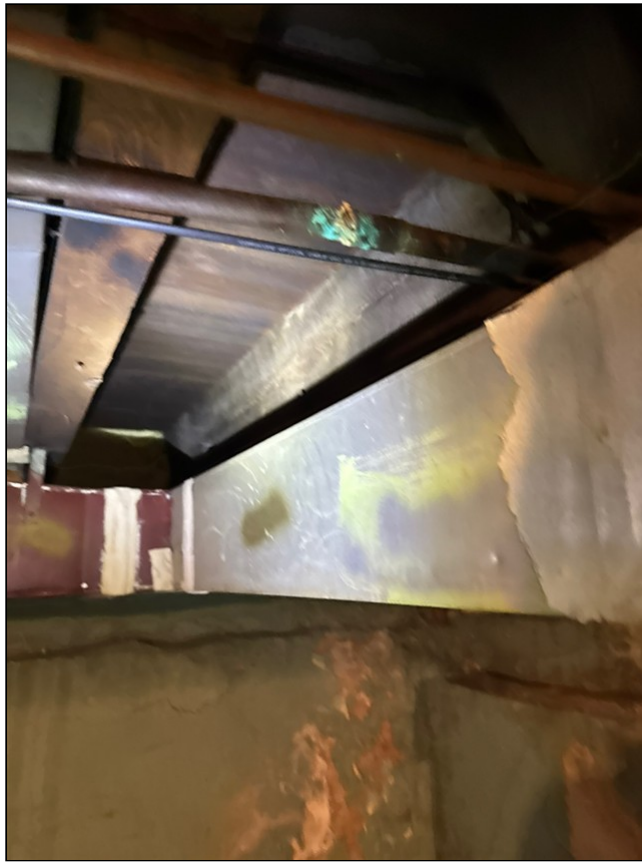
5.0

(2) Corrosion was observed at visible copper piping. No active leakage was observed at the time of inspection unless otherwise noted, but corrosion should be monitored. A qualified plumber should repair or

replace affected piping if leakage develops or conditions worsen.

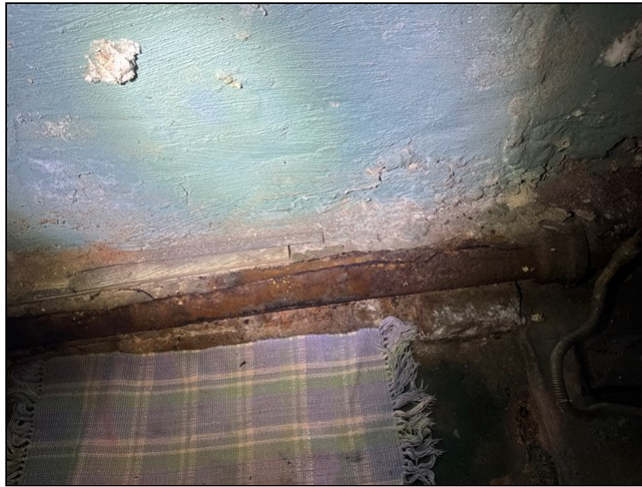
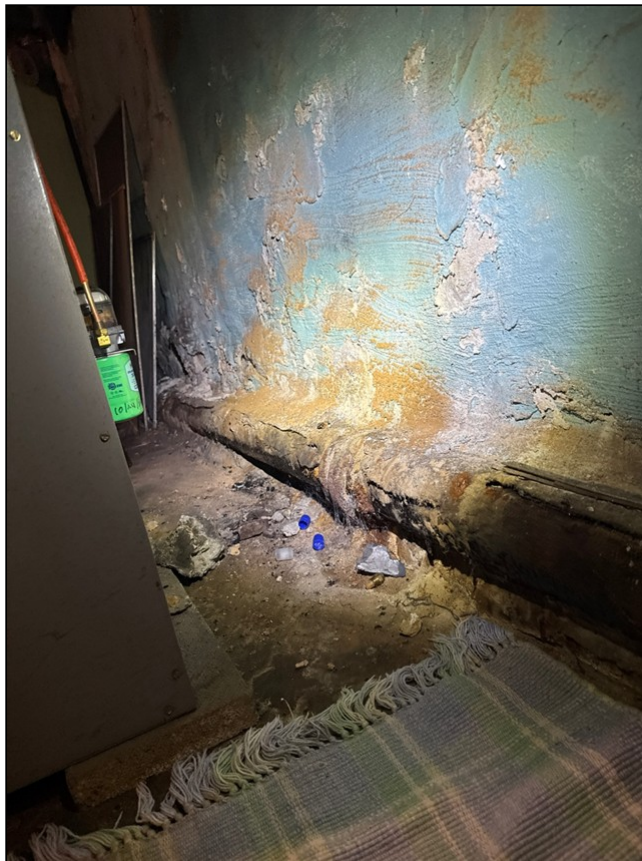
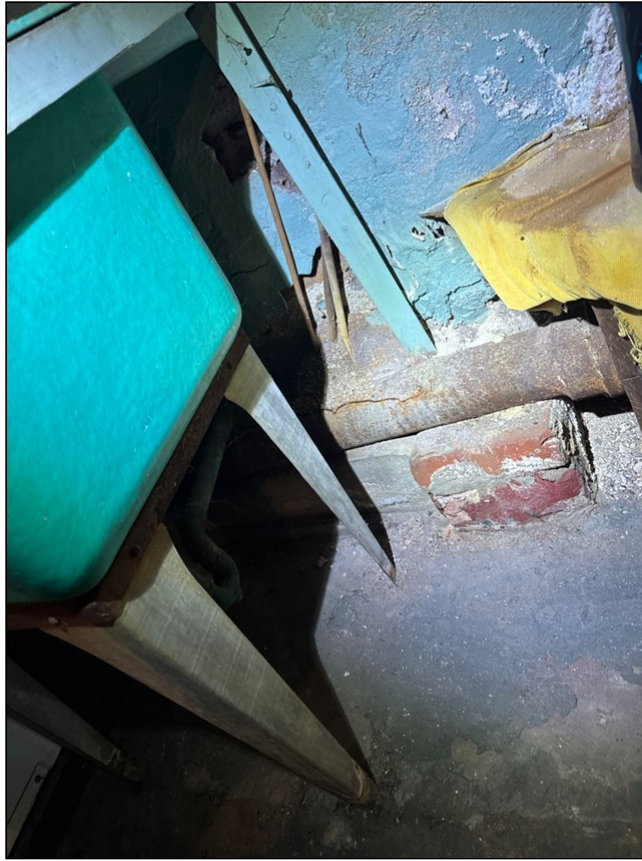
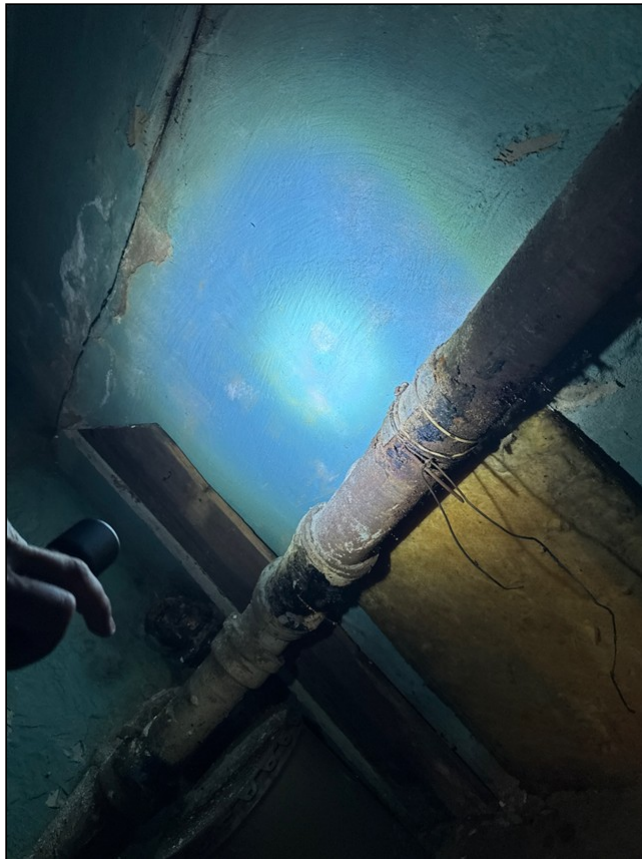
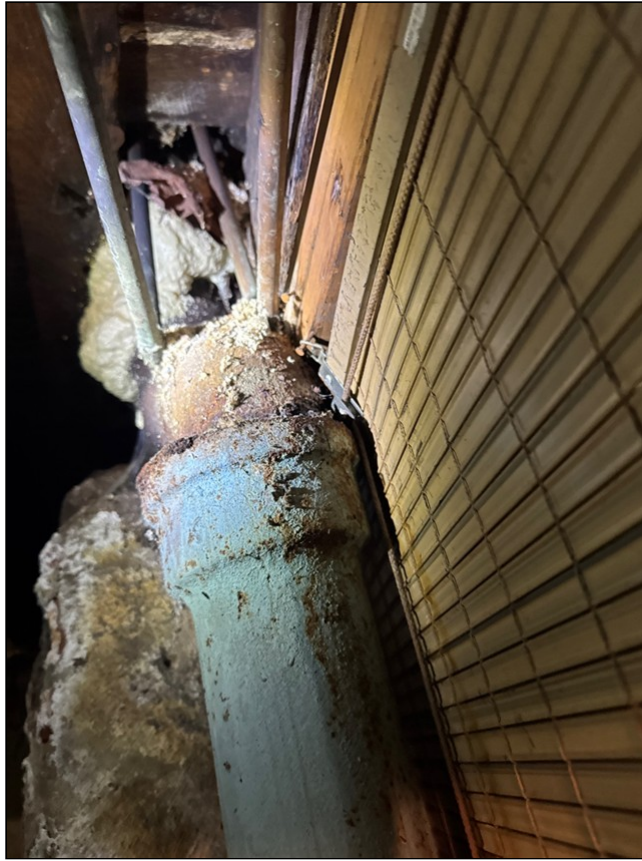
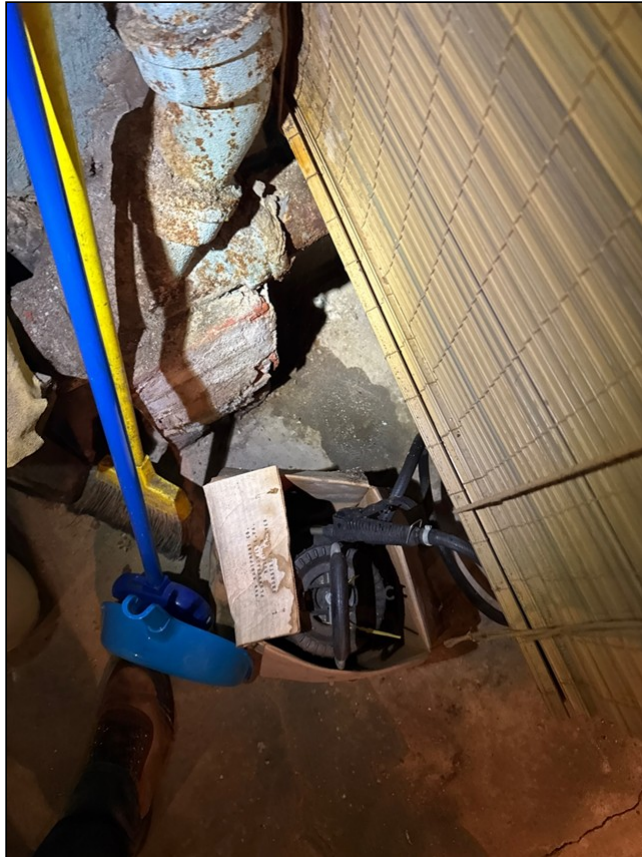
5.5

The entire cast-iron sewer line is cracked and rotted and needs to be completely replaced. A qualified plumbing contractor should further evaluate and replace.

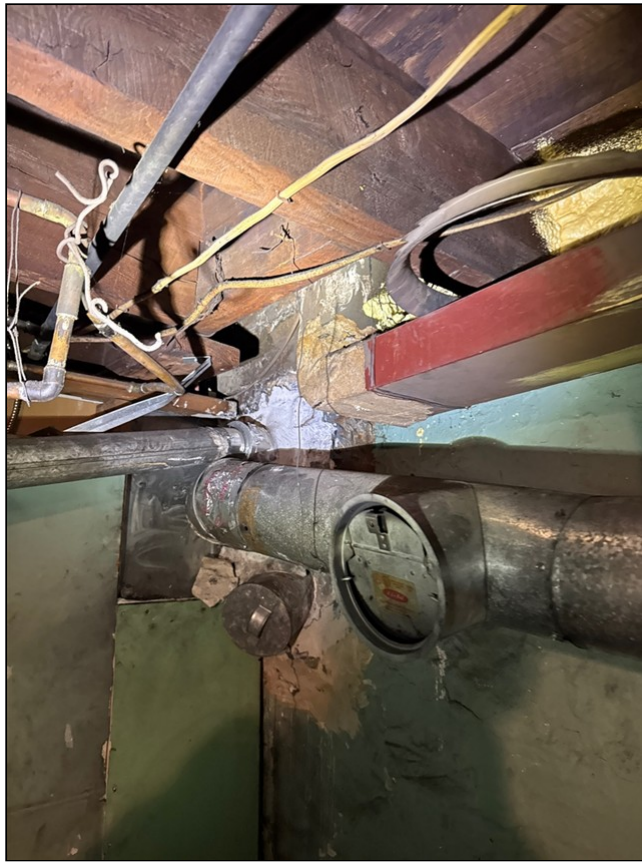
6.1

Pipe or duct wrap suspected of containing asbestos was observed. Confirmation requires laboratory testing. Avoid disturbing the material and consult a qualified asbestos contractor before repair, removal, or

renovation.

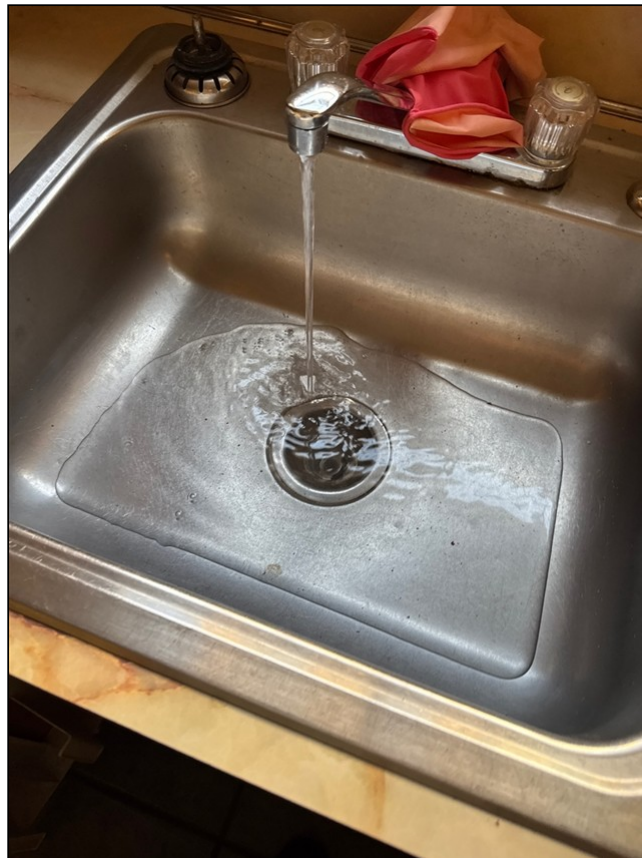
7.2

(1) The kitchen sink is clogged. Drain cleaning is needed.

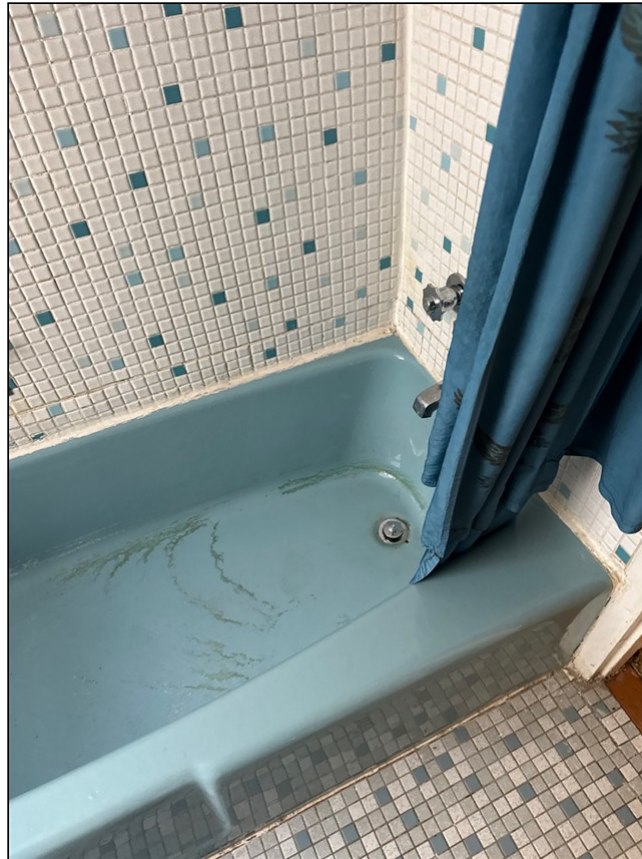
7.4

A significant number of cosmetic imperfections were observed throughout the home, including finishes, doors, hardware, ceilings, walls, floors, fixtures, and similar surfaces. Cosmetic conditions are not fully itemized during this inspection and are generally noted only in broad terms. Anticipate cosmetic repairs, corrections, and upgrades after purchase.
